AGARD CONFERENCE PROCEEDINGS No. 315

## Aircraft Corrosion

Papers presented at the 52nd Meeting of the AGARD Structures and Materials Panel  
held in Çeşme, Turkey on 5-10 April 1981.

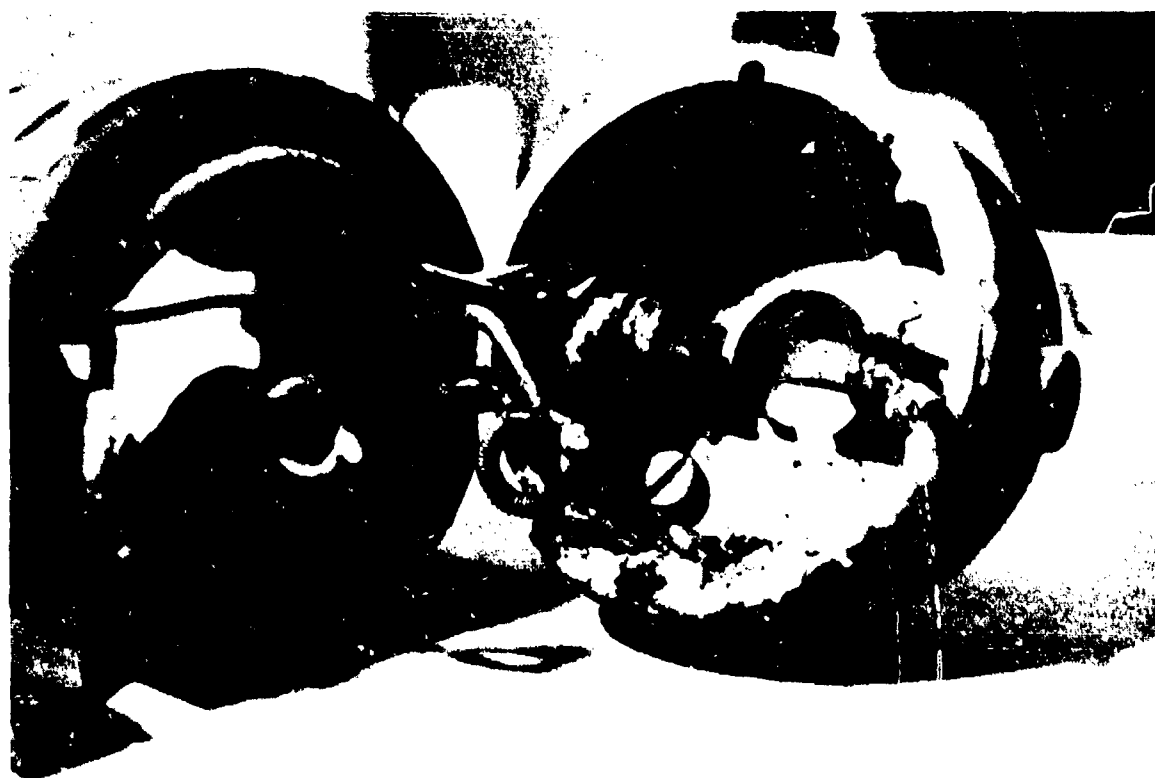
Fig.8 Corrosion of electrical motor

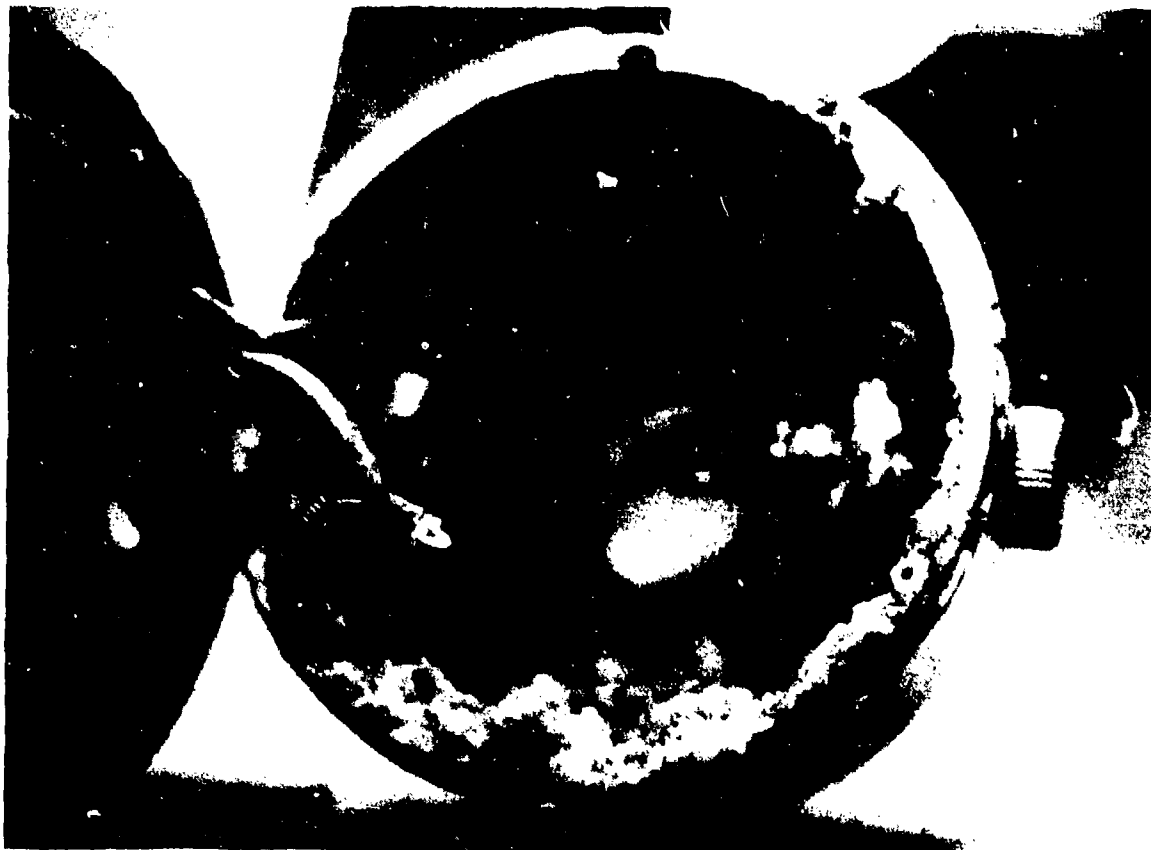
Fig.9 Electrical motor corrosion

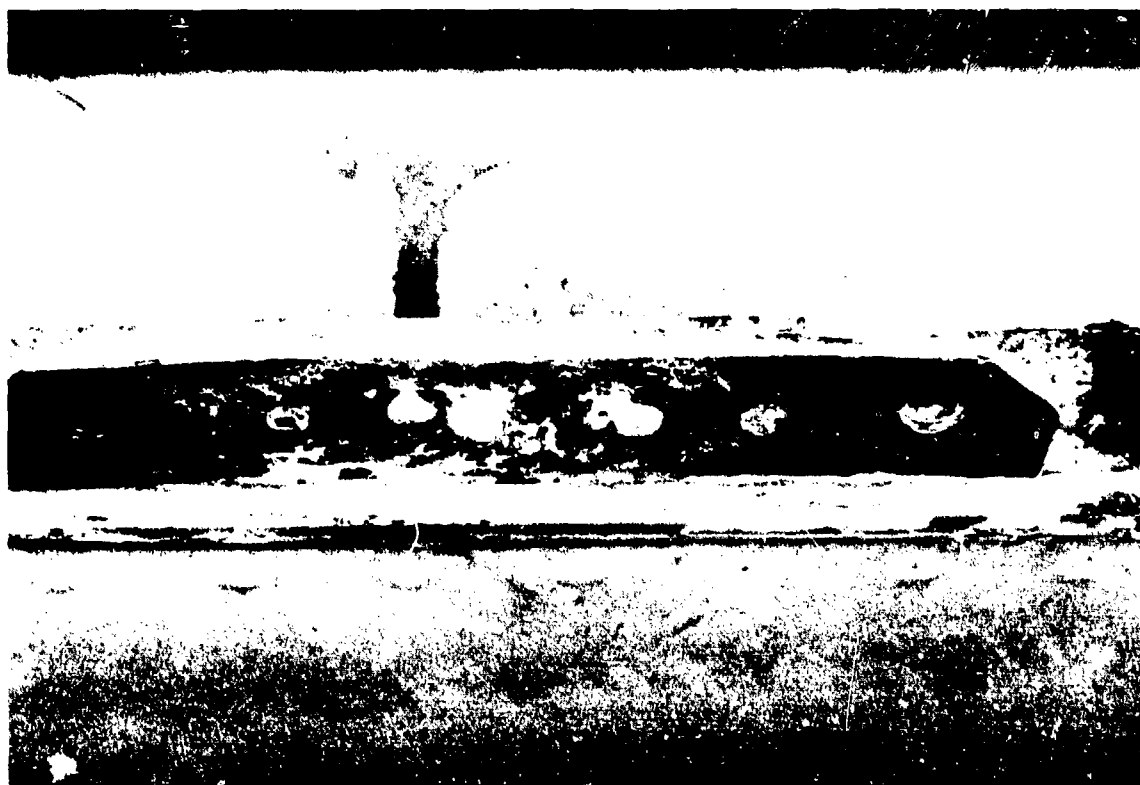
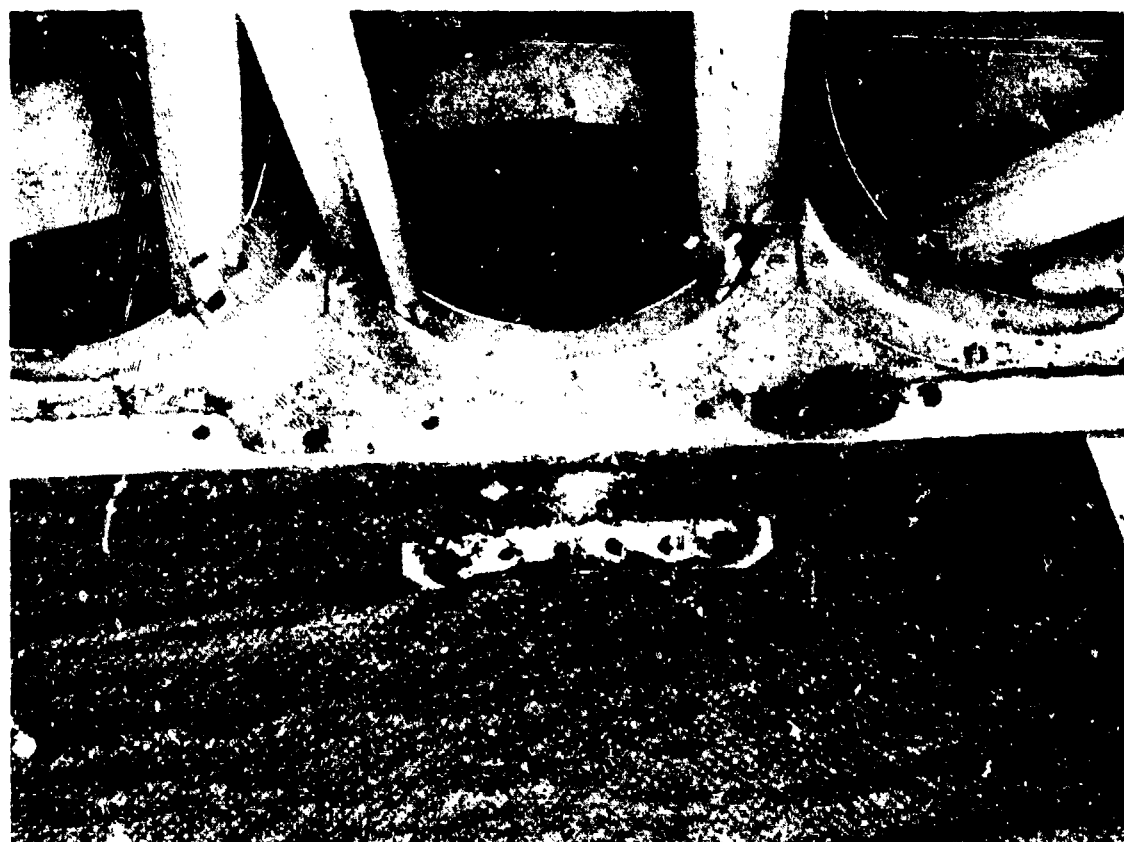
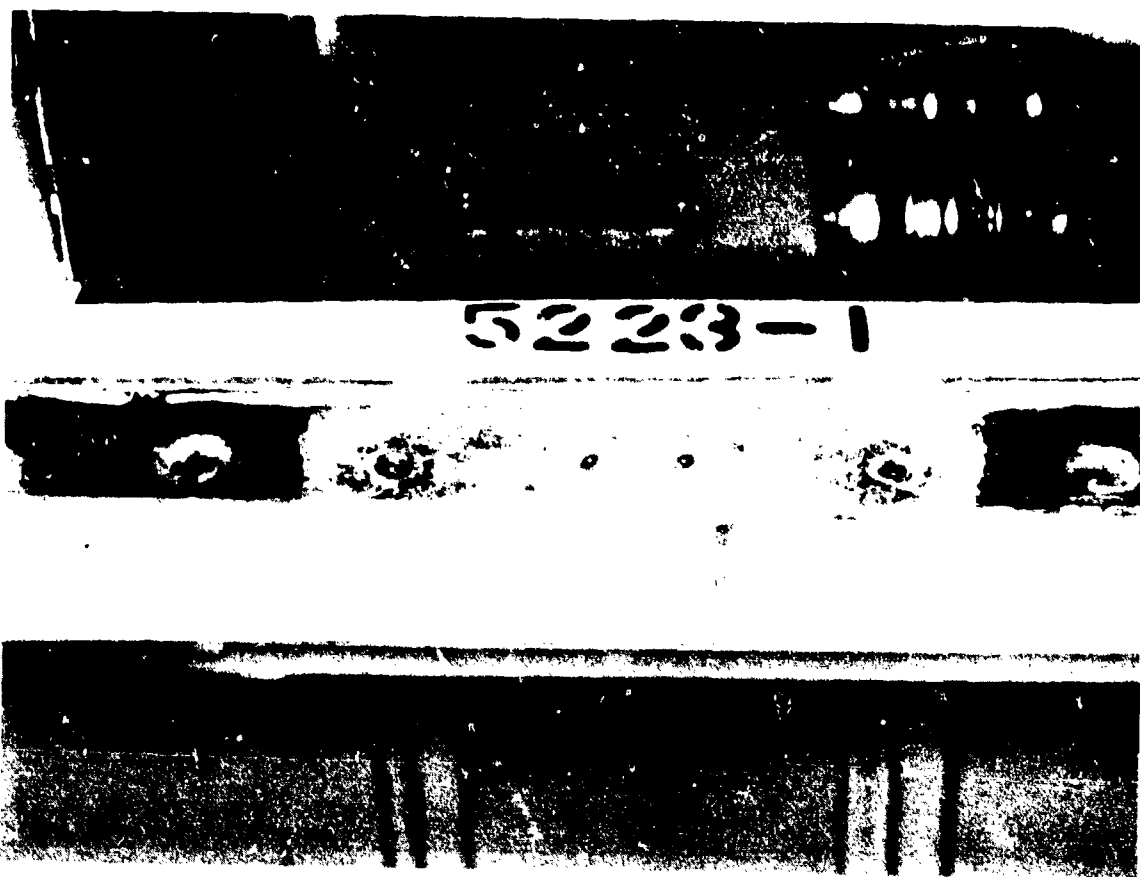
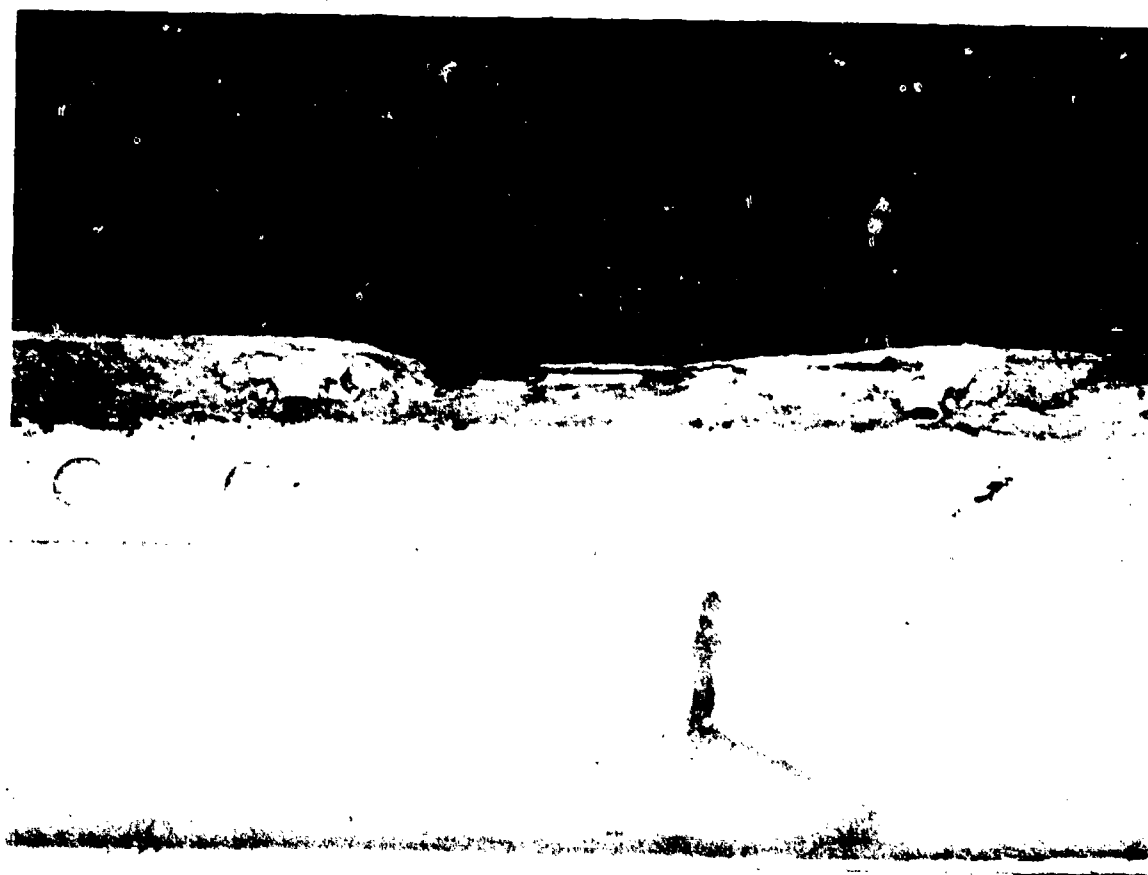
Fig.12 Corrosion caused by the use of dissimilar metal with insufficient sealant

Fig.13 Corrosion caused by the use of dissimilar metal with insufficient sealant

Fig.14 Corrosion caused by the use of dissimilar metal with insufficient sealant

Fig.15 Corrosion caused by the use of dissimilar metal with insufficient sealant

Fig.16 Corrosion caused by the use of dissimilar metal with insufficient sealant

c. We still see some corrosion from the use of dissimilar metals contact when insufficient sealant is used on faying surfaces as illustrated by photographs of dissimilar metals. Hidden corrosion is detected by nondestructive inspection methods during rework. (See Figures 12 - 16) These include ultrasonic, X-ray and eddy current inspection and neutron radiography on double skin areas and on areas behind stringers, etc. where corrosion is caused by moisture entrapment. Corrosion due to entrapped moisture ranges from light surface corrosion to severe exfoliation, and when discovered, normally requires material replacement by depot activities and the addition of sealants to the faying surfaces. Surface contact type corrosion problems would be minimized by material selection if suspected corrosion prone areas of an aircraft are constructed of less corrosion prone materials, if dissimilar metal contacts are minimized and properly insulated, if better protection is provided for the materials used during construction as illustrated by photographs. (See Figures 17 - 20)

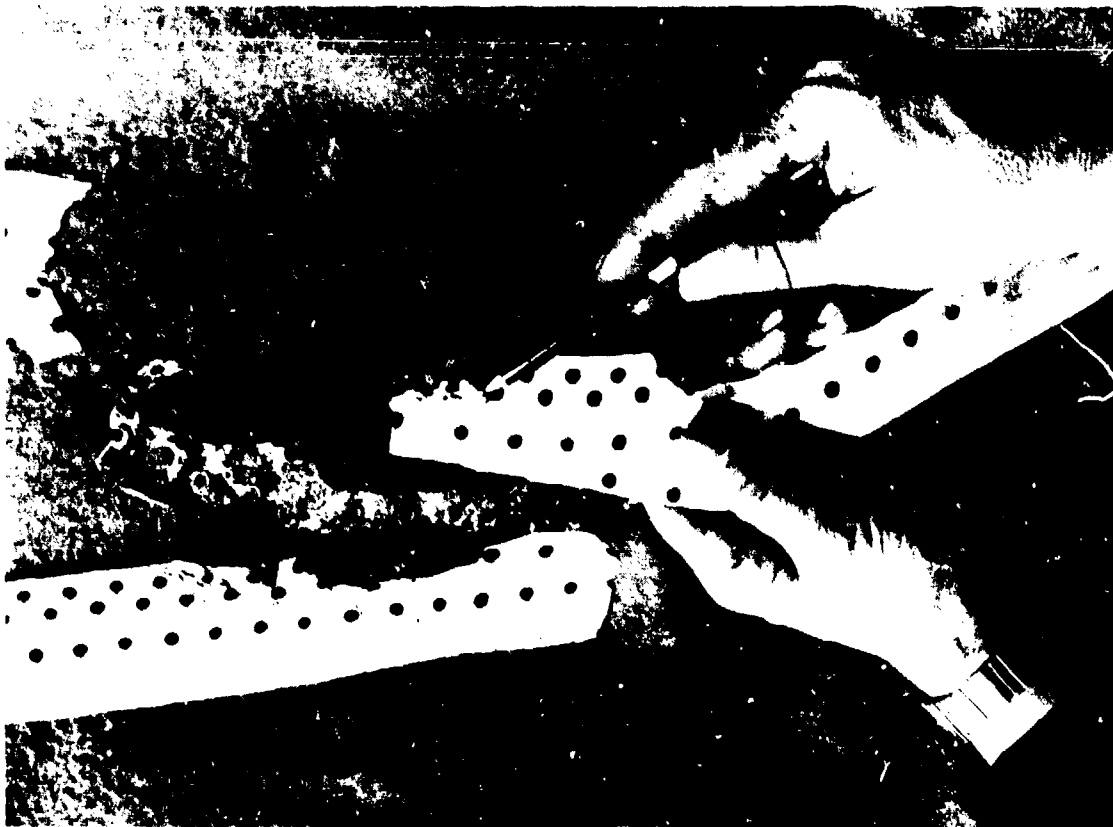
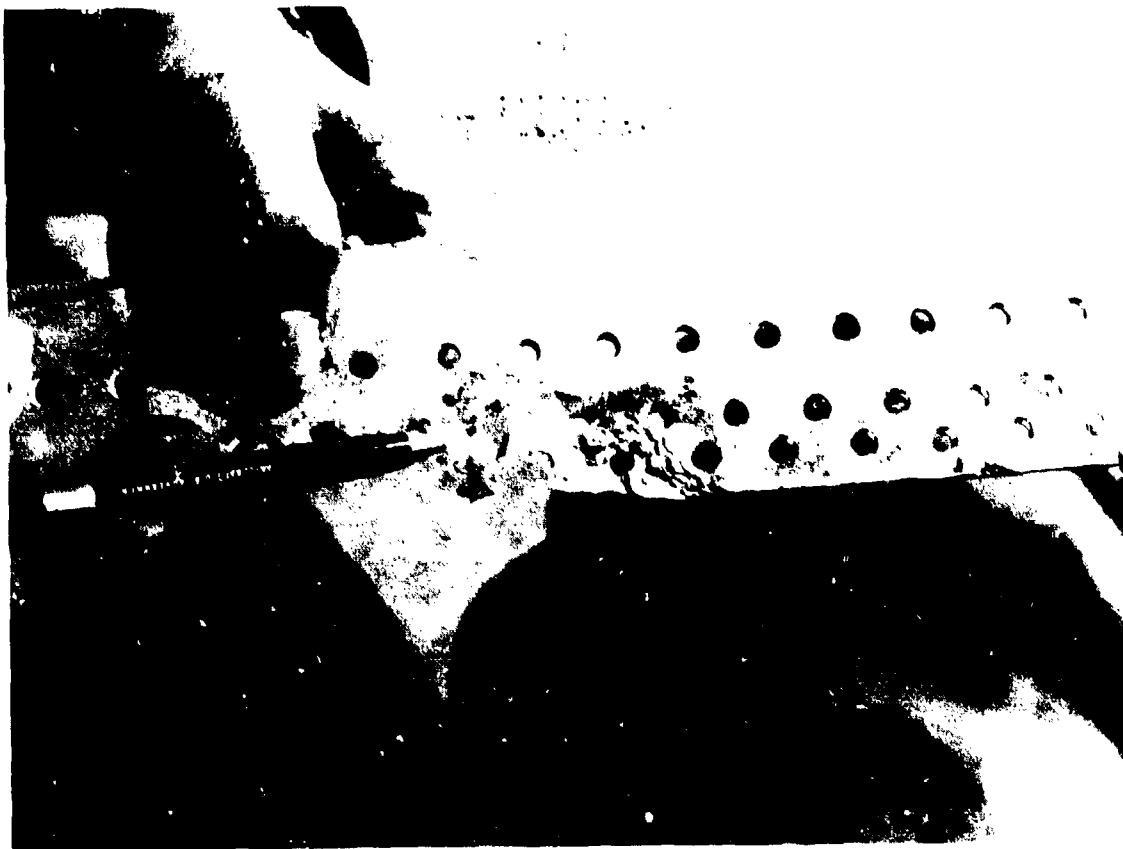
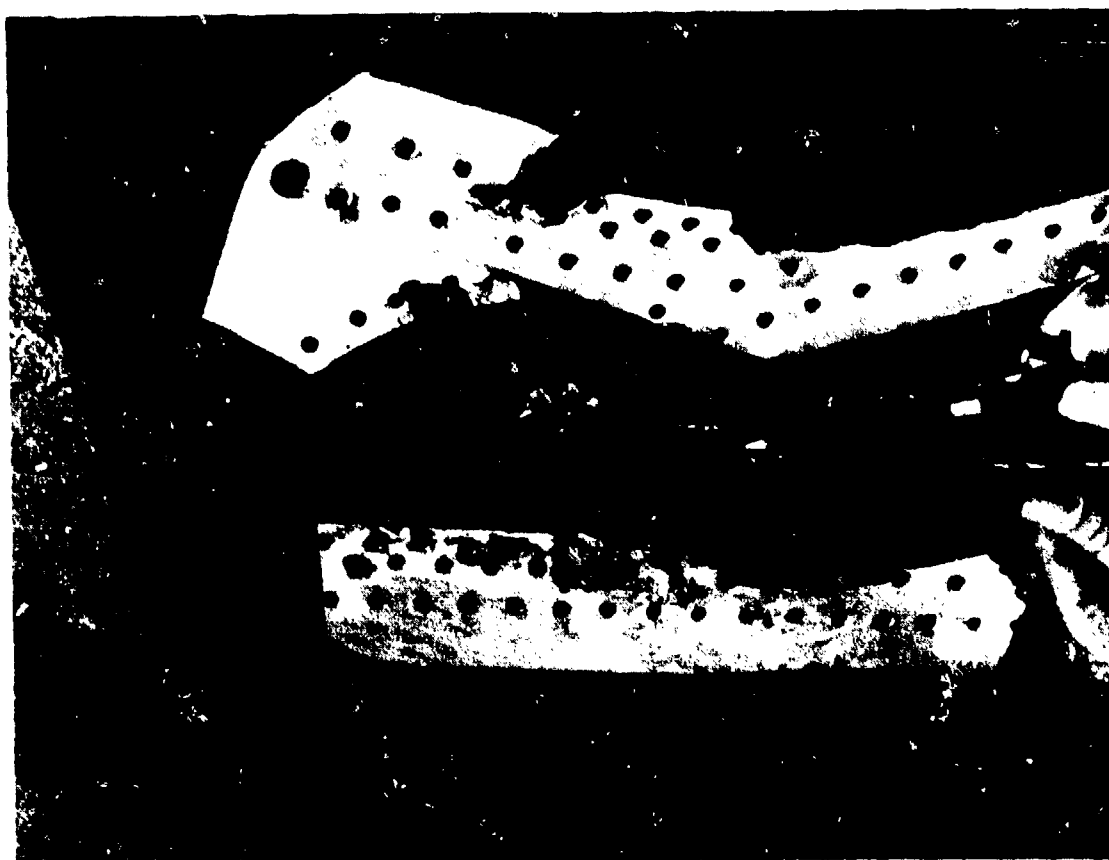
Fig.17 Improper material selected for use

Fig.18 Improper material selected for use

Fig.19 Improper material selected for use

Fig.20 Improper material selected for use

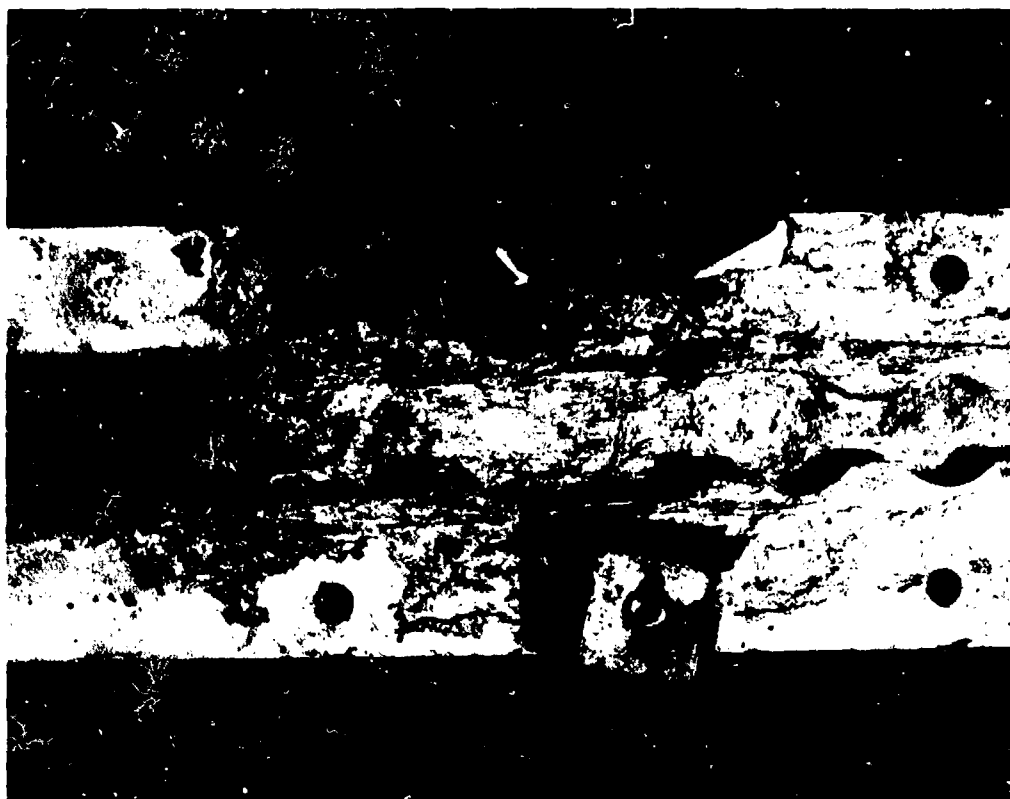
Fig.3 Illustration shows a badly corroded seat track located beneath a galley unit. Corrosion has occurred where a steel galley attachment fitting was located in the light alloy seat track in the presence of liquids. The galley load restraint capability has been severely degraded

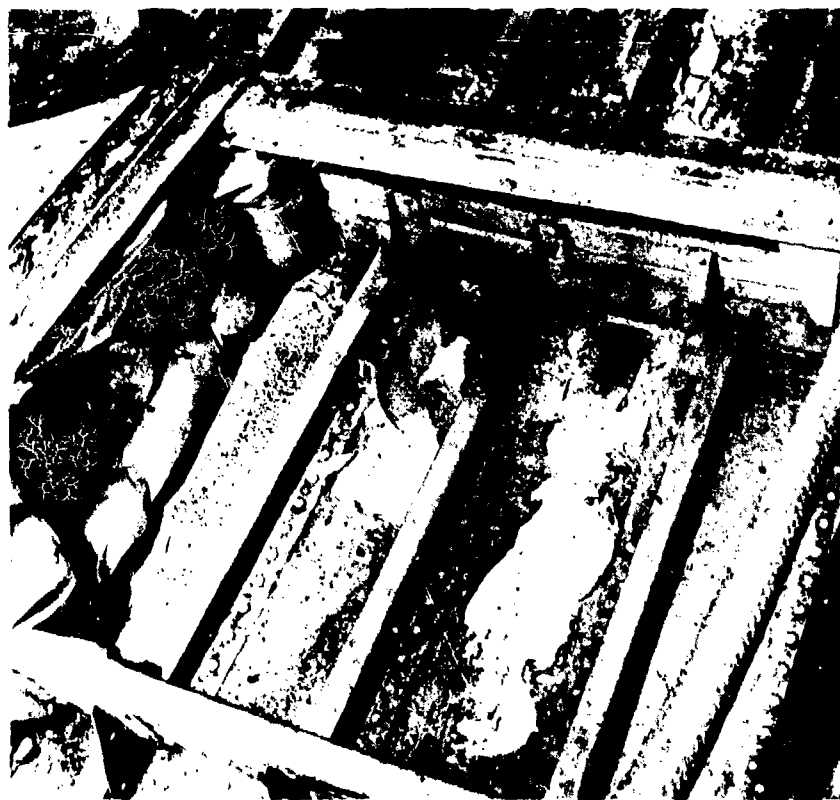
Fig.4 Photograph shows the excellent paint removing qualities of certain products carried as Air Freight! Portion of structure shown was located beneath a freight hold floor and liquid spillage caused the problem

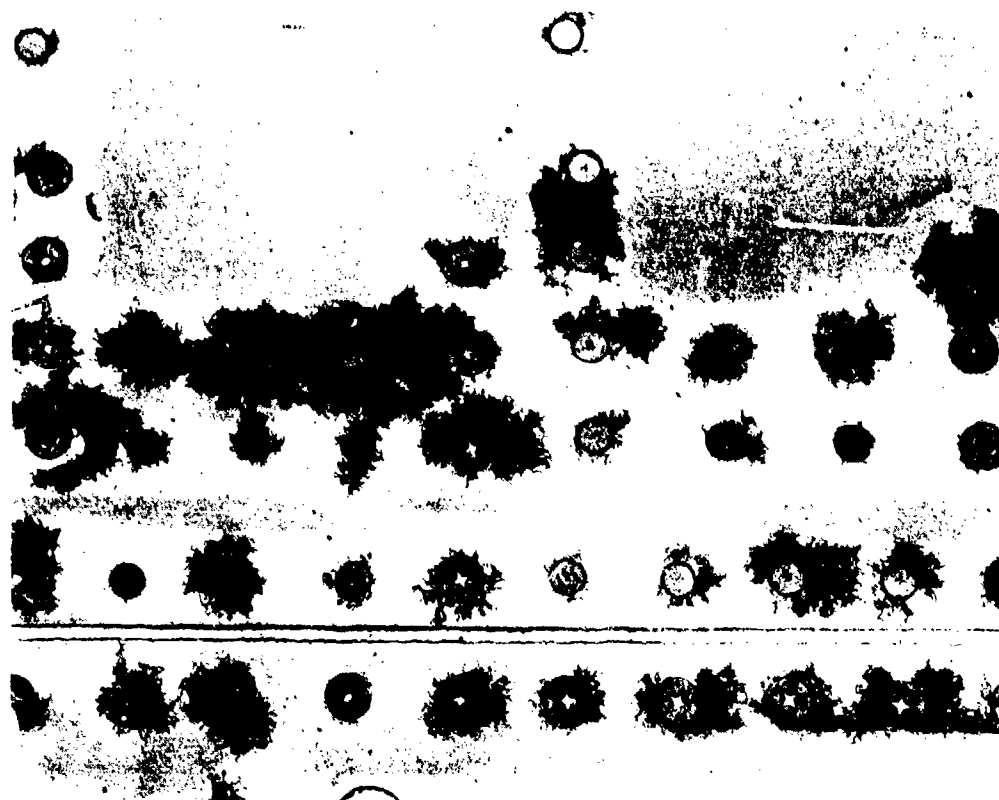
Fig.5 Illustration of filiform corrosion around steel fastener heads in light alloy (7000 series) upper wing surface

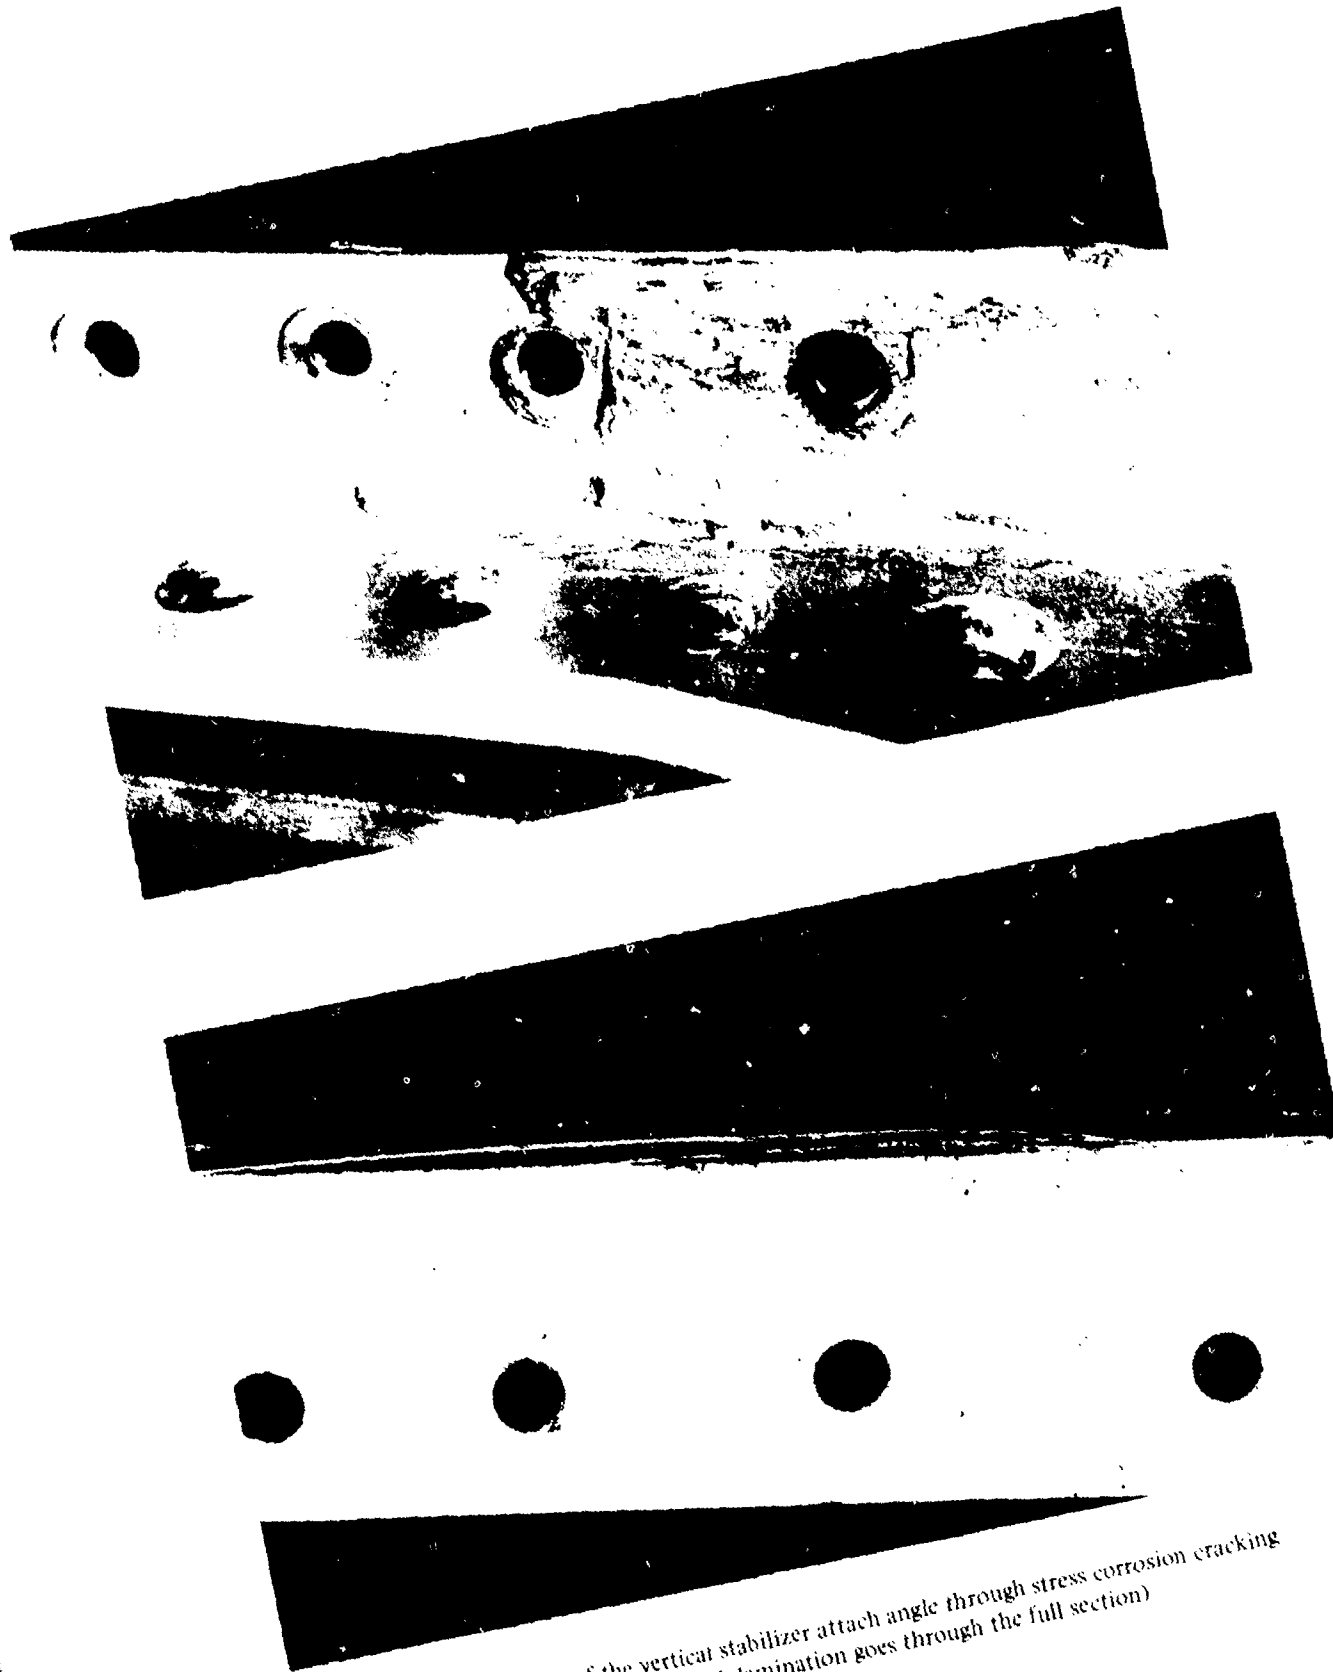
Fig.5 Damage of the vertical stabilizer attach angle through stress corrosion cracking and exfoliation (delamination goes through the full section)
